RCRA Closure Plan Brick Shop Container Storage Area

Location: Estate of Chemetco, Inc.
3754 Chemetco Lane
Hartford, IL 62048

Prepared by: Gary J. Davis, CHMM
EH&S Manager

Date: January 29, 2008

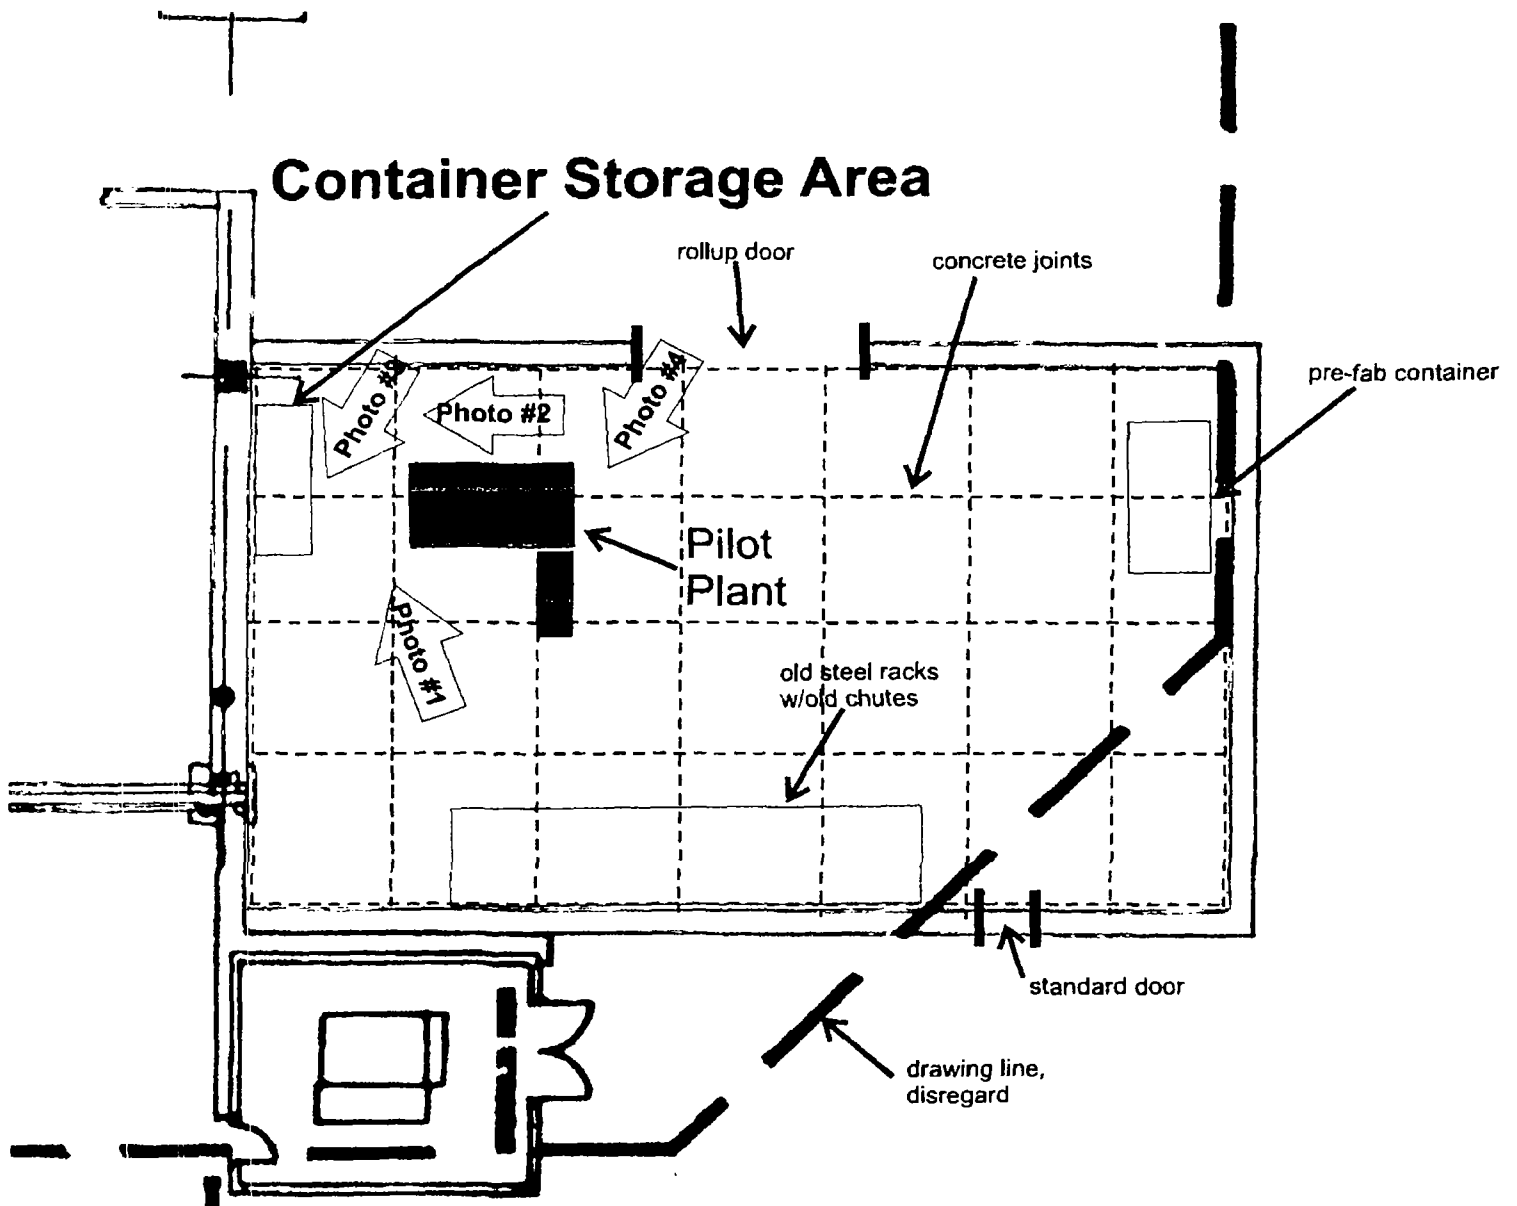
Figure 4

Dimensions: 50' wide by 80' long by 20' high (Brick Shop Drawing, Figure 4)

Cracks, etc.: As shown in Figure 4, cracks do exist along joints in the container storage area that appear greater than ¼ inch.

Brick Shop Drawing
w/Photo Locations
(Scale: 1" ~ 20')

1. Pressure wash container storage area three times. Collect all wash waters and dispose according to RCRA.
2. Inspect joints for integrity. If not seal, repair or remove and replace joint sealant.
3. Upon completion of the above, submit Certification of Closure.
